**4-Point Inspection Report**

# Paul J. Customer

### 1234 Anywhere Drive

# **Four- Point Inspection Report**

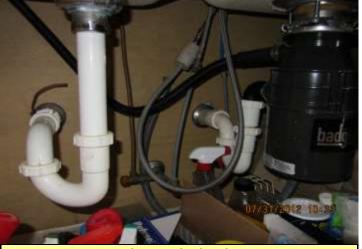
Kitchen Sink Plumbing PVC Drain Lines & CPVC Supply Lines

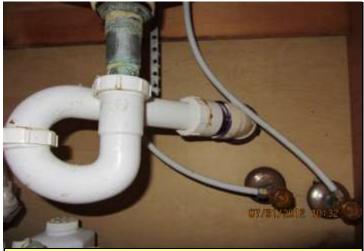
Bathroom Plumbing PVC Drain Lines & CPVC Supply Lines

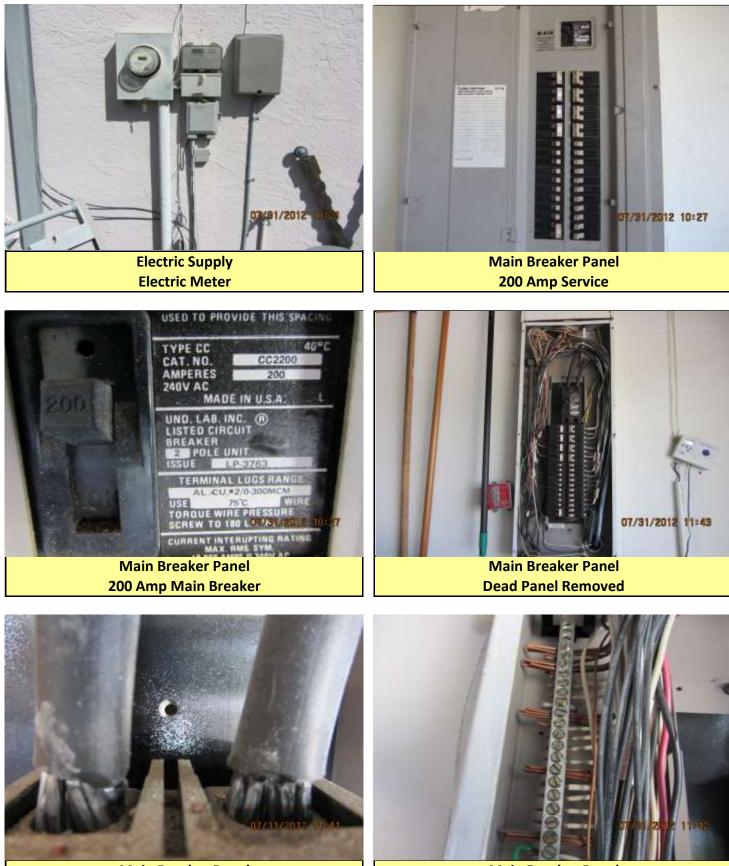
Main Breaker Panel Copper Branch Wiring
