Inspection Report

Brine Development Services, llc (CGC1516754)

dba **STRUCTURAL PLUS**

1 Structural Plus Avenue

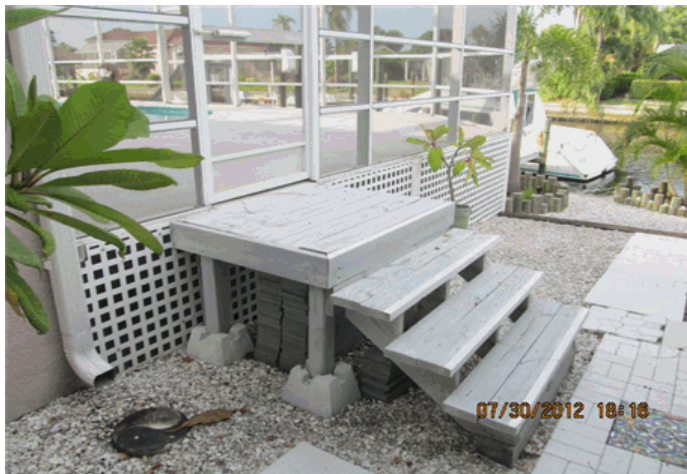
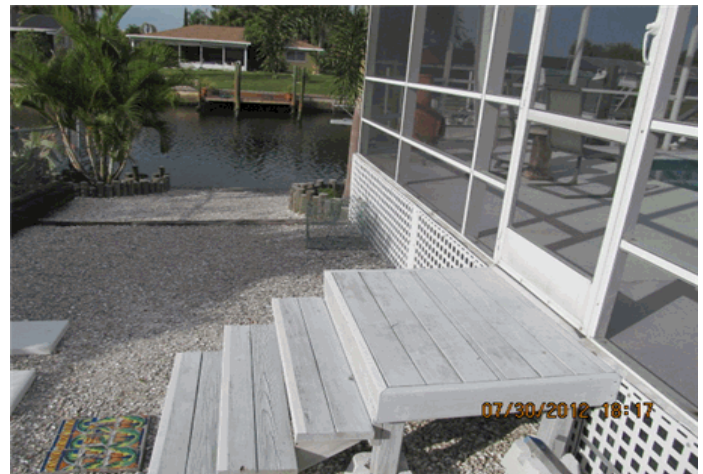
2) Back Entrance Conditions

Wood Steps to Concrete Deck. The visible and accessible areas of the deck appeared to be in serviceable condition at the time of the inspection. **Steps to pool deck on both sides of residence do not have hand rail.** See Photos

| Section | Condition# | Comment |
|---|---|---|
| Exterior | 2 | Wood Steps to Concrete Deck. The visible and accessible areas of the deck appeared to be in serviceable condition at the time of the inspection. Steps to pool deck on both sides of residence do not have hand rail. See Photos |

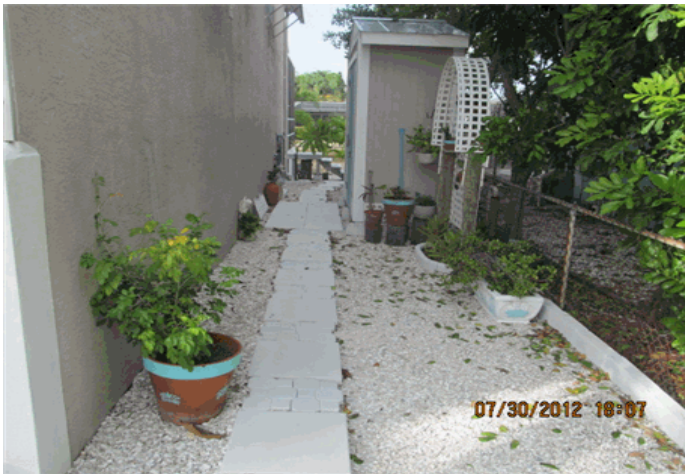
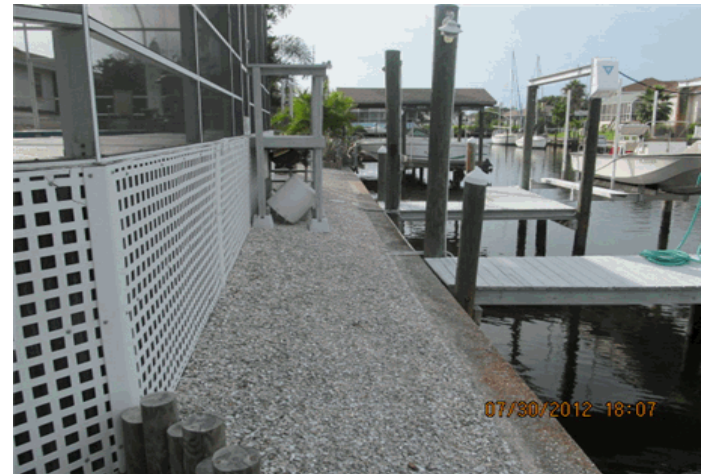
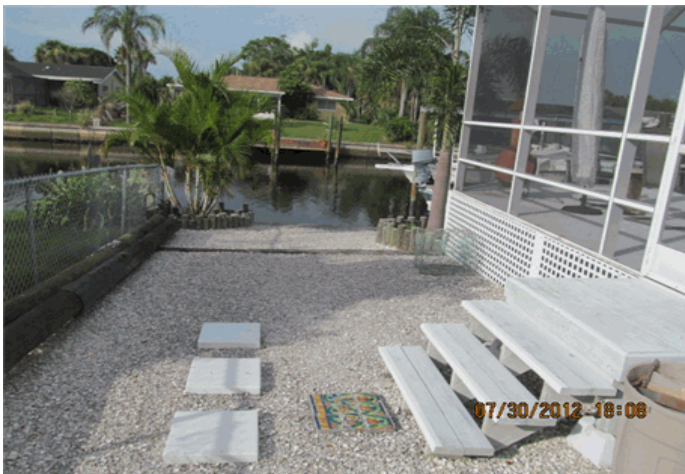
8) Grading Conditions

Grading of the soil near the foundation appears to be in serviceable condition.

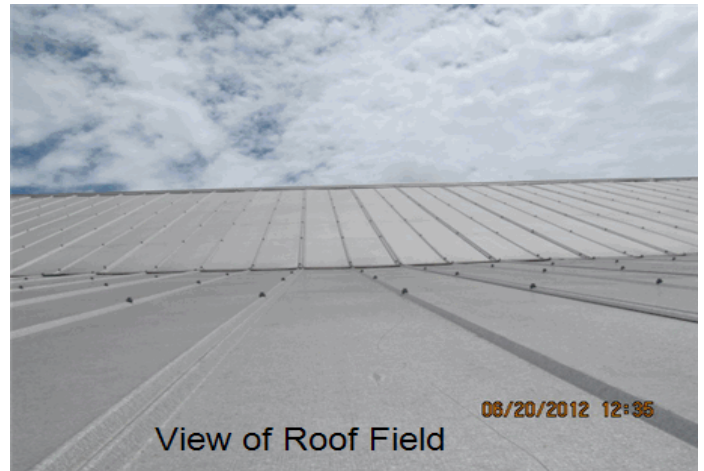
12) Roof Covering Condition

The roof covering shows normal wear for its age and appeared to be in serviceable condition at the time of the inspection.

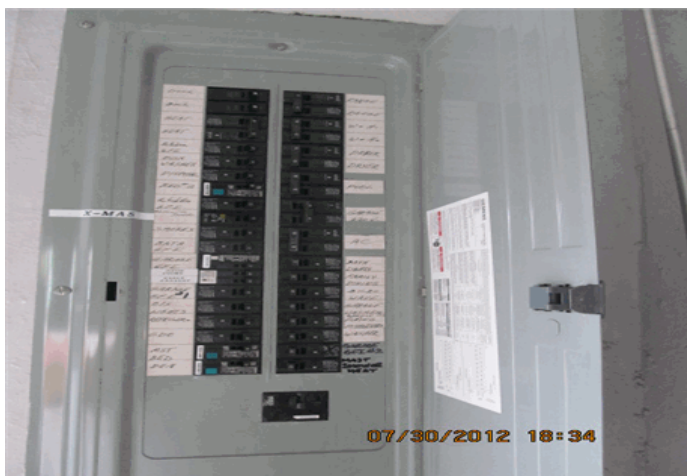
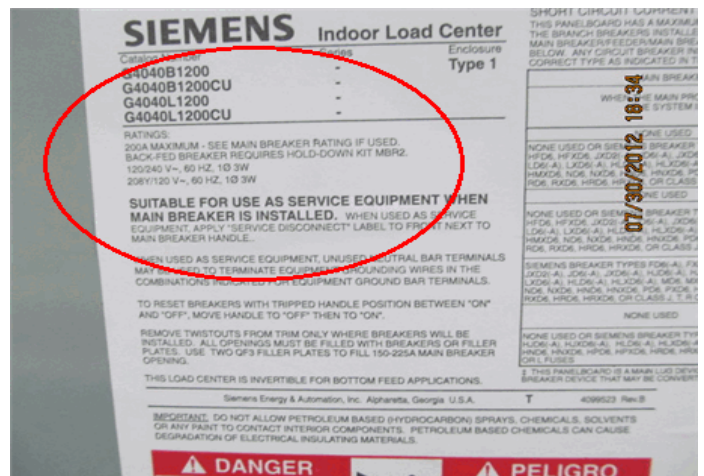
25) Wiring Methods **AS** The main power cable is aluminum (Main power cable from local power company). The branch cables are copper.

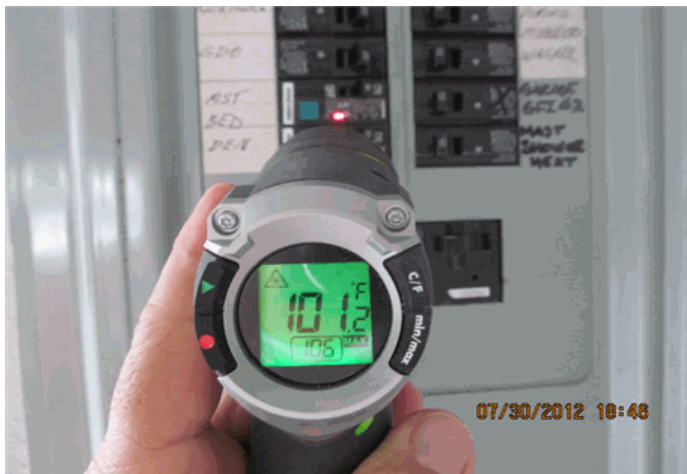
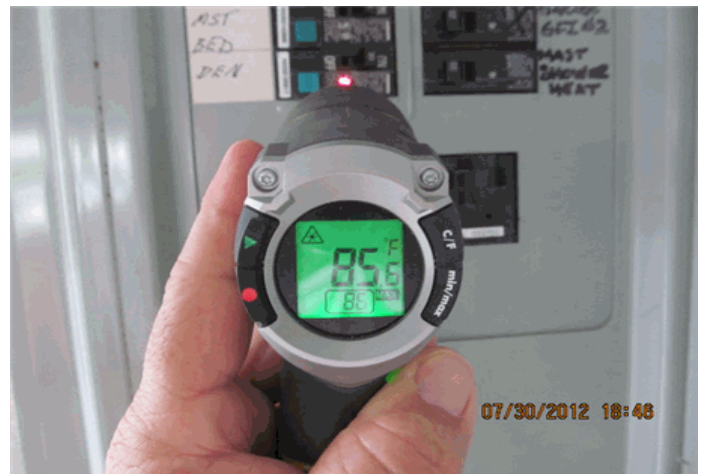
26) Electrical Panel Conditions

The main panel appeared to be in serviceable condition at the time of the inspection.
Temperature difference between one breaker and the other breakers in panel. This observation does not determine that a circuit breaker is bad or going bad. We advise this be further inspected/monitored be a licensed professional electrician. See Photos.

| Section | Condition# | Comment |
|---|---|---|
| Electrical | 26 | The main panel appeared to be in serviceable condition at the time of the inspection. Temperature difference between one breaker and the other breakers in panel. This observation does not determine that a circuit breaker is bad or going bad. We advise this be further inspected/monitored be a licensed professional electrician. See Photos. |

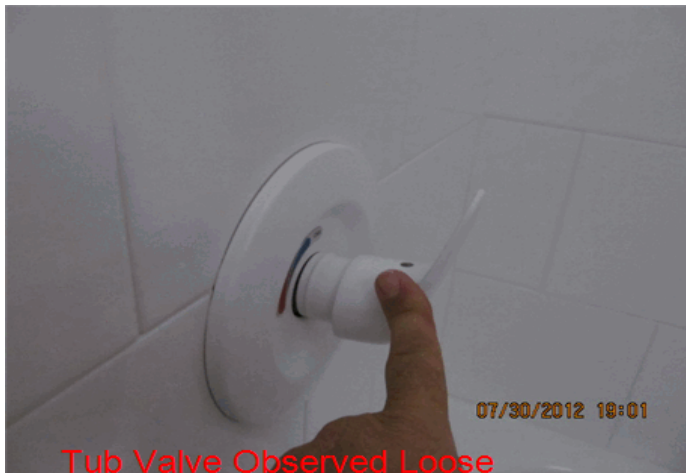
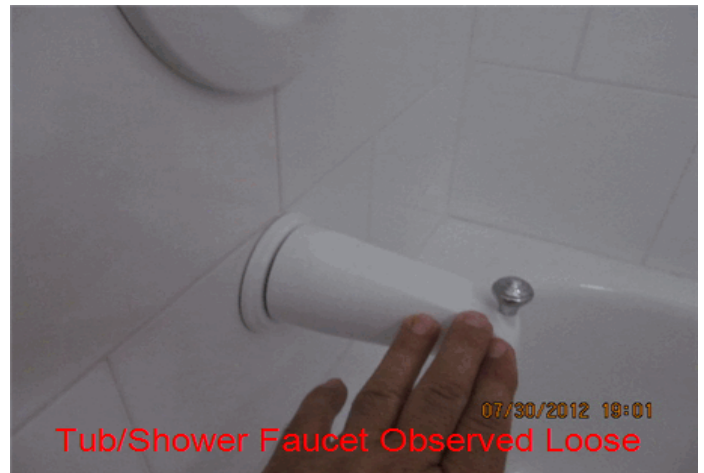
71) Shower - Tub Conditions

Caulking is recommended at the Master Bath Shower floor. The tub faucet and shower plumbing was loose at the wall in 2nd bath . Recommend repair. The bathtub, faucet, and drains appeared to be in serviceable condition.

| Section | Condition# | Comment |
|---|---|---|
| Bath(s) | 71 | Caulking is recommended at the Master Bath Shower floor. The tub faucet and shower plumbing was loose at the wall in 2nd bath . Recommend repair. The bathtub, faucet, and drains appeared to be in serviceable condition. |

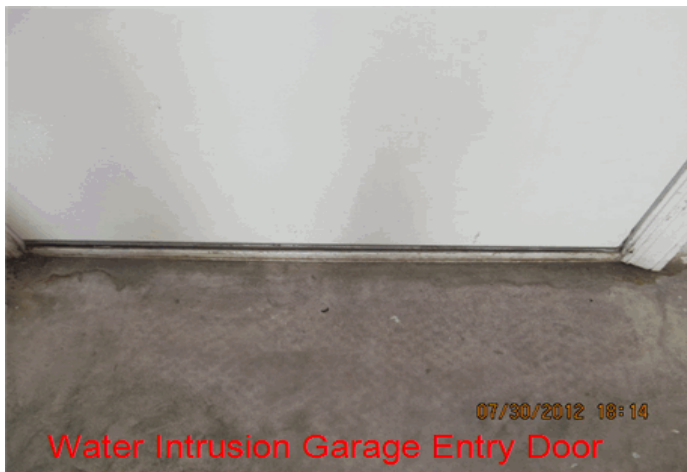
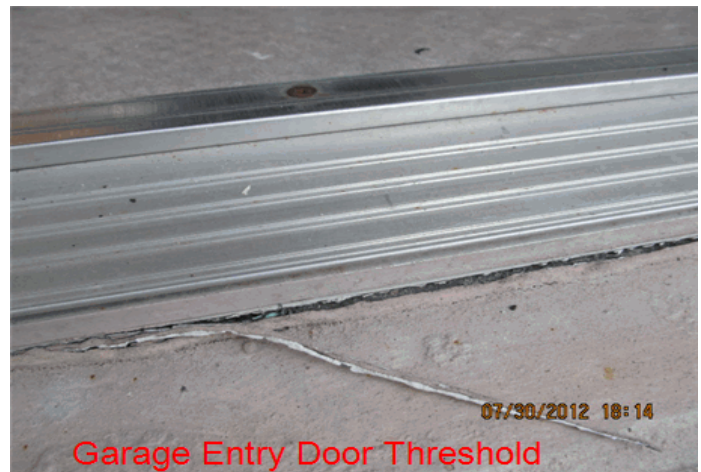
85) Door Conditions

Moisture was observed at rear entry garage door. Recommend further evaluation and repair as needed by a qualified / licensed contractor. See Photos

| Section | Condition# | Comment |
|---|---|---|
| Garage | 85 | Moisture was observed at rear entry garage door. Recommend further evaluation and repair as needed by a qualified / licensed contractor. See Photos |

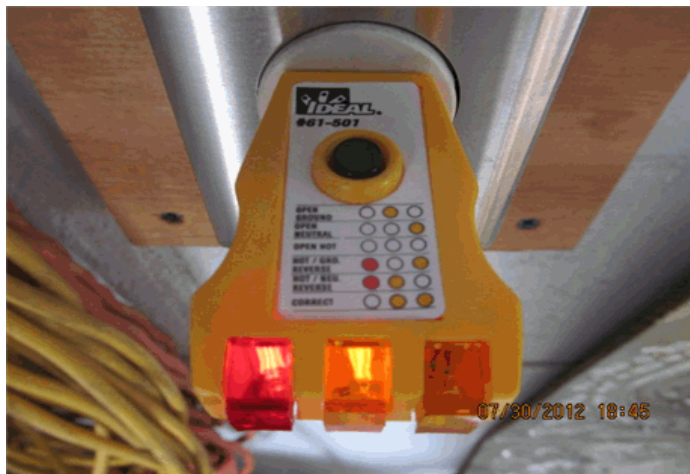
87) Electrical Conditions

Appeared Serviceable at time of inspection. **Receptacle in garage showed reversed polarity condition. See Photo**

| Section | Condition# | Comment |
|---|---|---|
| Garage | 87 | Appeared Serviceable at time of inspection. Receptacle in garage showed reversed polarity condition. See Photo |
